Steel Mains Pty Ltd
ABN: 73 004 843 056

Materials & Products – Coatings
Ref: PT 15271B
Date: January 22, 2019

Examination of SINTAKOTE® in Service

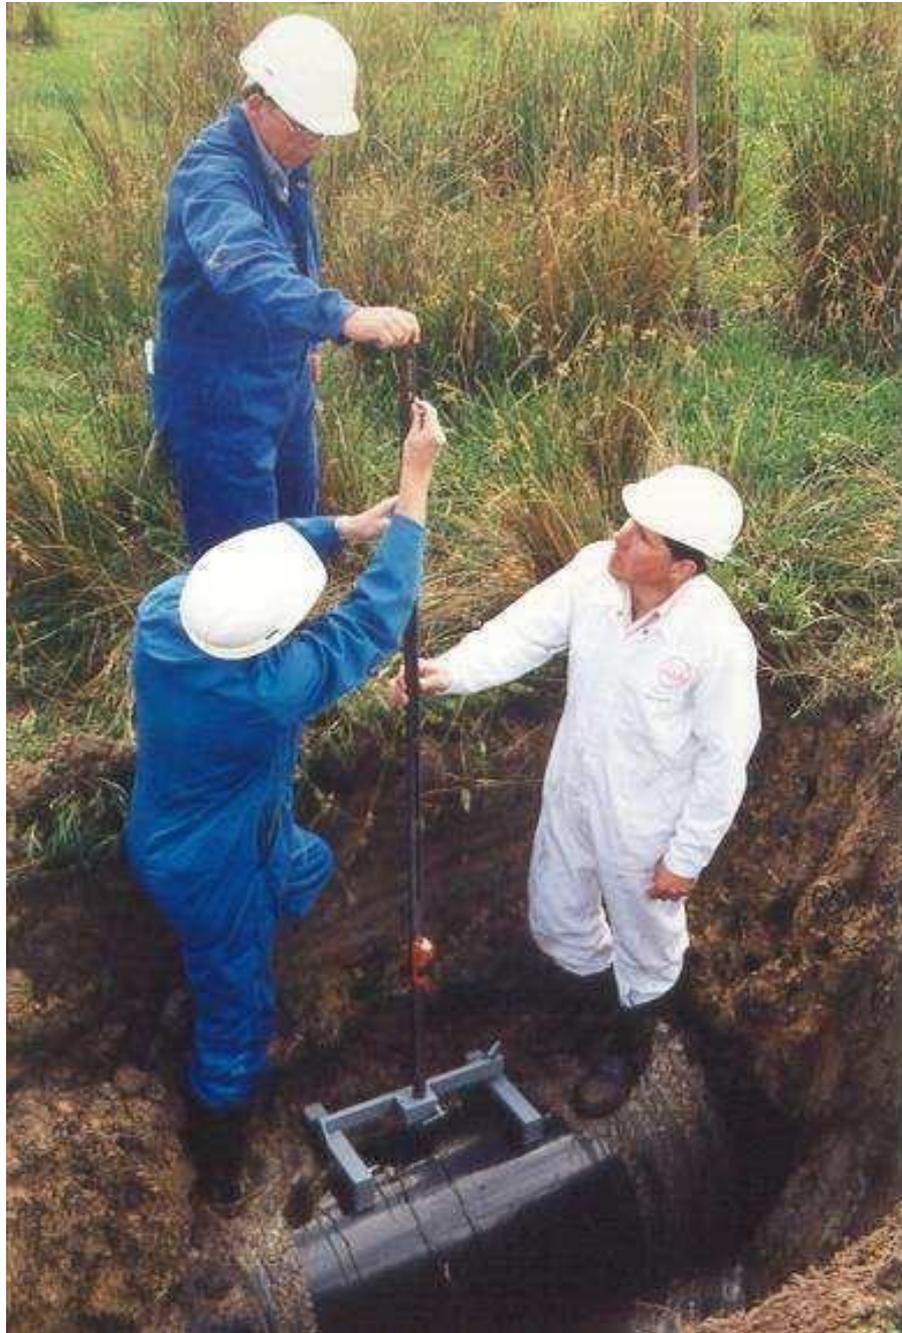
In all cases the adhesion was high, and easily met the factory bond test requirement at the time of coating application. In no case was there any evidence of corrosion under the removed coating, with bright steel evident. This indicates SINTAKOTE is continuing to perform its main function of providing a barrier oxygen and water permeation.

Figure 1 - Site 1, Horsham, 1991, showing the 8-year-old 724mm OD SINTAKOTE® steel pipe and preparations for impact testing.

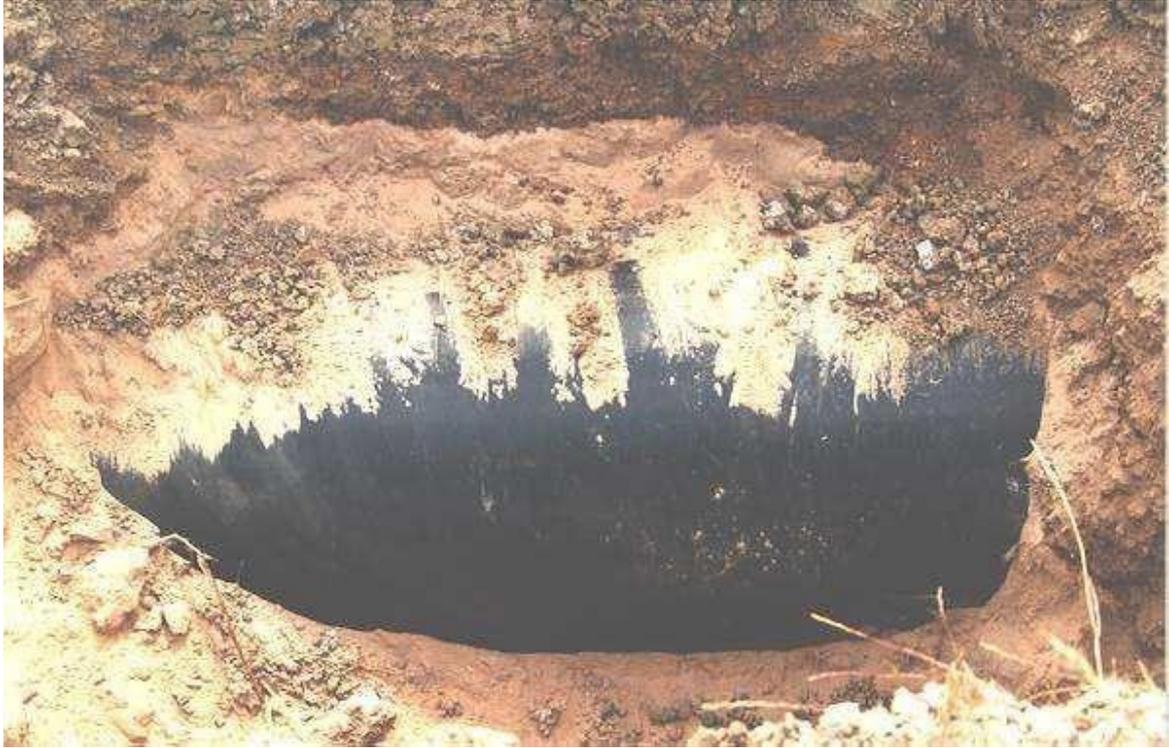
No samples were taken from Site 2; however, it can be seen in Figures 2 and 3 that a sand backfill was placed around the pipe.

Figure 2 – Site 2, Horsham, 1991, showing the 14-year-old 724mm OD pipe with soil being removed.

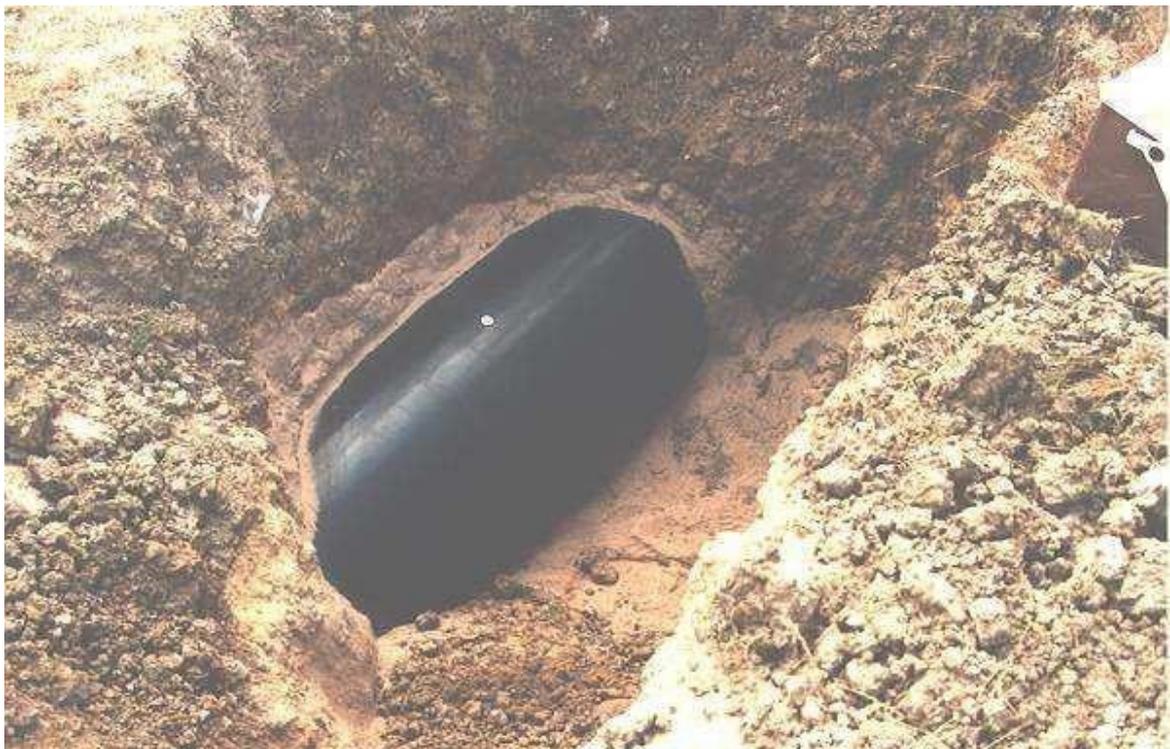
Figure 3 - Site 2, Horsham, 1991, showing the 14-year-old pipe ready for examination (with 50c coin for perspective).

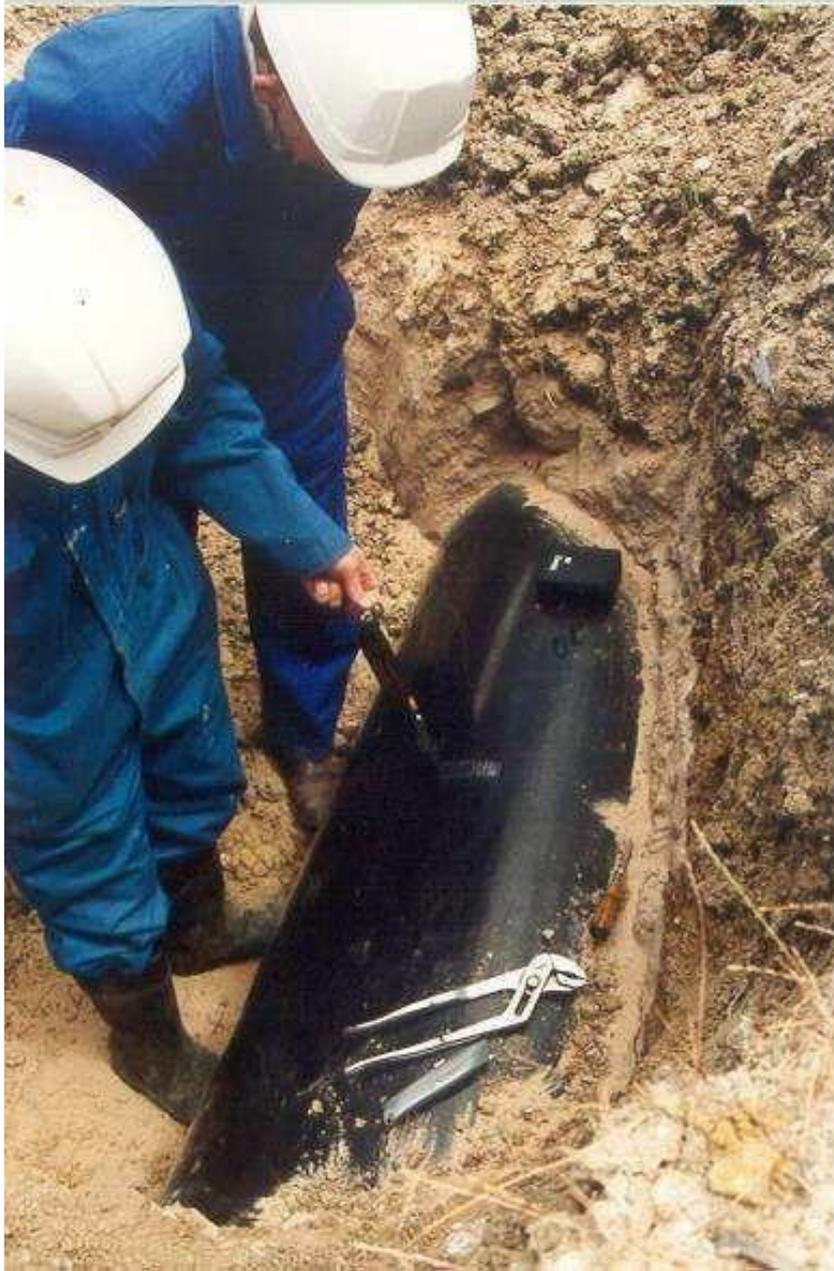
Figure 4 – Site 2, Horsham, 1991, undertaking the bond adhesion test on the 14-year-old pipe.

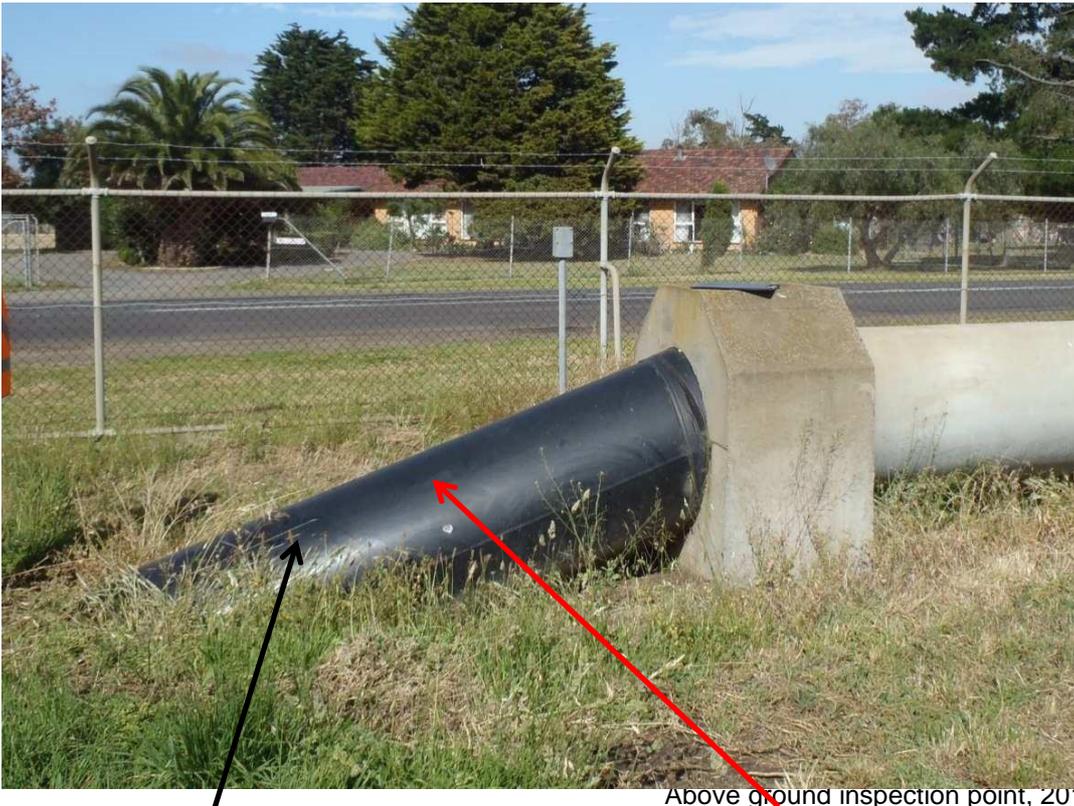
Visual examination of all the coating when examined in 2004, 2013 and 2018 indicated it was in excellent condition, with no evidence of crazing, cracking, or any other surface defects, such as blisters, cracks, perforations, etc. Note that the first signs of thermal degradation/ageing can usually be identified by visual examination, and no such signs were evident.

High voltage continuity inspection was carried out on the coating at 15kV in 2013 and 2018. No coating deterioration holidays were found, however there was minor third-party damage at one point, which was thought to be related to grass cutting activities.

Figure 7 – Site 3, Geelong, 2004 & 2013. Close up view of the above ground pipeline section (taken facing West).

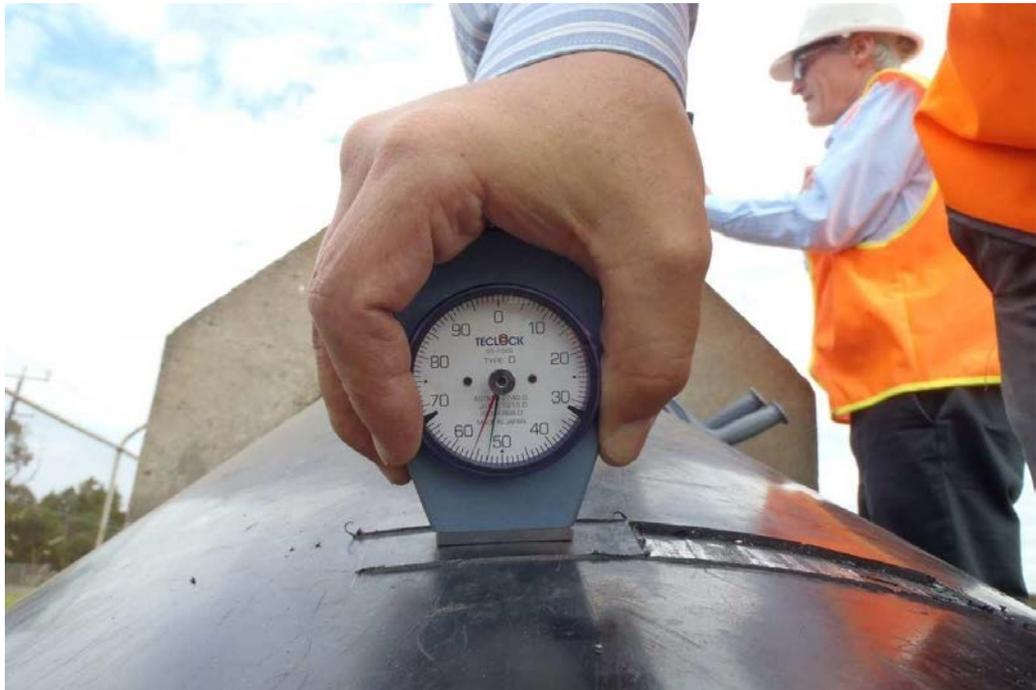
There has been a slight, minor increase in the average coating hardness over the testing period. This is not thought to be significant, especially when considering the uncertainty of measurement for such testing. Fig. 8 shows the hardness test being undertaken.

Figure 8 – Site 3, Geelong, 2013. Shore D hardness test on above ground pipe.

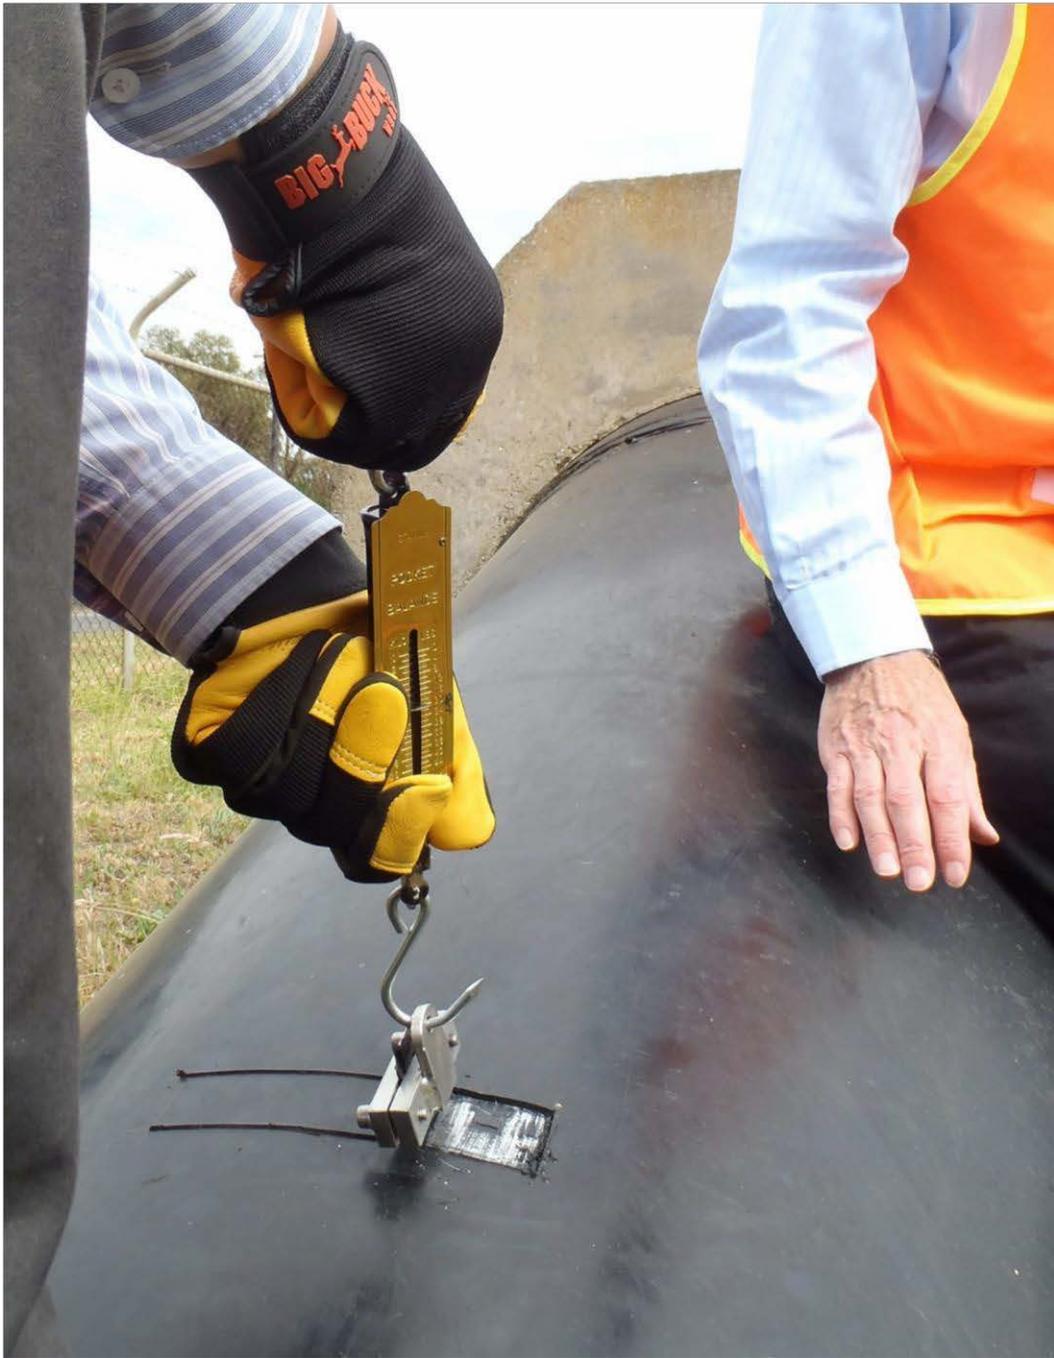
During all 2004, 2013 and the 2018 inspections the coating was tightly adherent, and this made it very difficult to undertake the test without the coating fracturing first. On all 3 occasions a definitive result could not be obtained, with every indication the bond was well above 2.5N/mm in all tests. The values recorded in Table 1 represent the load achieved just prior to coating fracture. The steel surface underneath the removed coating was bright, with no evidence of corrosion, indicating the coating has satisfactorily performed its primary function of providing a barrier oxygen and water permeation.

Figure 9 - Site 3, Geelong, 2013. Bond testing the above ground pipe.

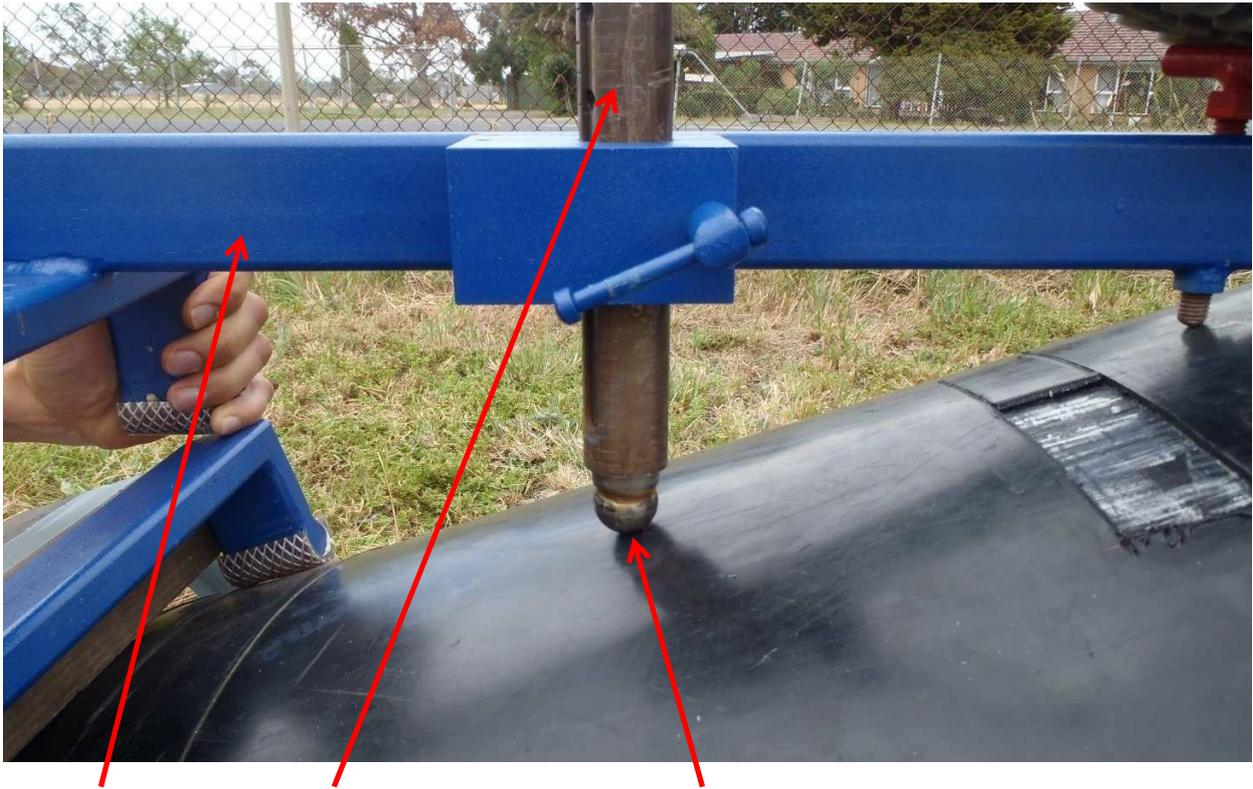
The coating thickness was measured at 2.7mm at Site 3, indicating a specified minimum coating thickness of 2.5mm, and hence a required impact energy of 12.5J. One complication for above ground testing was the fact that the steel pipe was installed at an angle of approx. 20° to the horizontal (so the pipeline could transition from above ground to a considerable depth, as it had to go under the nearby road). This meant the impact could not be at 90° (as the drop tube had to be maintained vertical), thereby slightly diminishing the severity of the impact. To compensate for that the impact tests were done at 15J, representing a 20%

increase in impact loading on the minimum requirement. A 25mm diameter headed tup weighing 1kg was dropped from heights of 1.5m to achieve impact energy of 15J.

After the coating was impacted it was high voltage continuity tested at 15kV, and no holidays were found. This indicates a high level of coating ductility and indicates that there has been no measurable deterioration in the impact strength of the coating after 40 years in service. The oxygen induction temperature (OITemp) test provides a good measure of the thermal resistance of polyethylene and provides information on its remaining life. The OITemp is the temperature at which decomposition occurs in still air. This method was the specified method for polyethylene pipes in the 1980's and 1990's and required a result of $\geq 230^{\circ}\text{C}$ on new as-produced pipe to pass.

Figure 10 – Site 3, Geelong, 2013. Impact test set up on the above ground section. The left-hand side was elevated to ensure the drop tube was vertical.

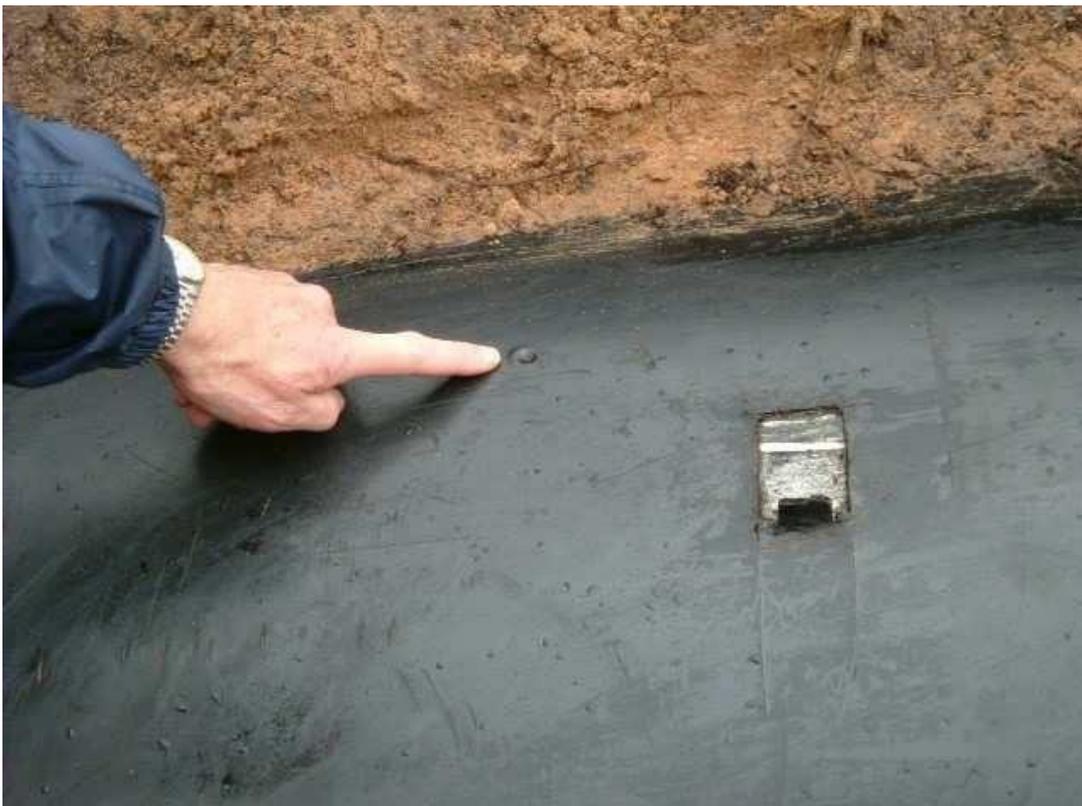
Impact testing was performed as detailed above in the above ground coating section. The results indicated there was no decrease in impact performance of the coating. In all cases the coating met the factory quality control requirement for newly applied coating, indicating no sign of deterioration.

Figure 11 – Site 3, Geelong, 2004. Close up view of buried pipe showing impact test indentation (LHS) and bond test (RHS)

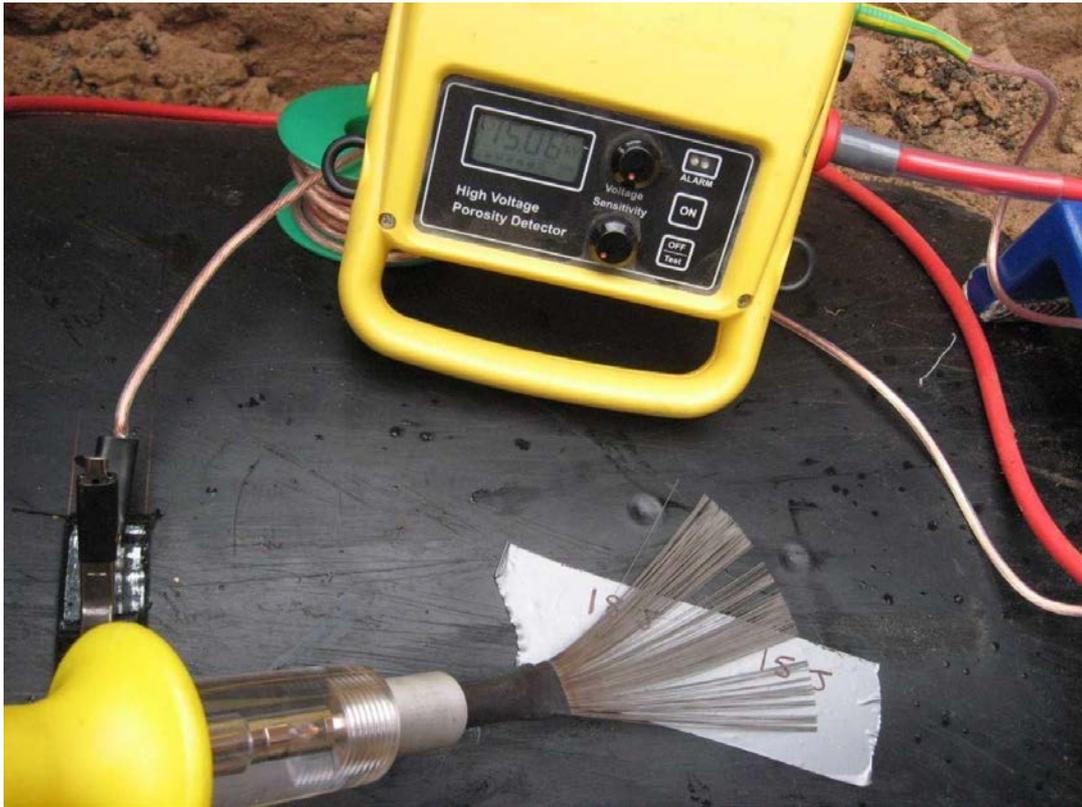
1. On both the above and below ground sections visual inspection showed the coating to be in excellent condition, with no evidence of crazing, cracking, or any other surface defects, such as blisters, cracks, or any perforations. In addition, no holidays due to deterioration were detected when the coating was subjected to a 15kV high voltage continuity test.

Figure 14 – Site 3, Geelong, 2013. High voltage 15kV continuity testing of impacted positions on buried pipe.
