FUSION BONDED POLYETHYLENE COATINGS – 40 YEARS ON

A Fletcher¹ & D Nicholas²

Pentair Water Solutions Pty Ltd¹ & Nicholas Corrosion Pty Ltd²

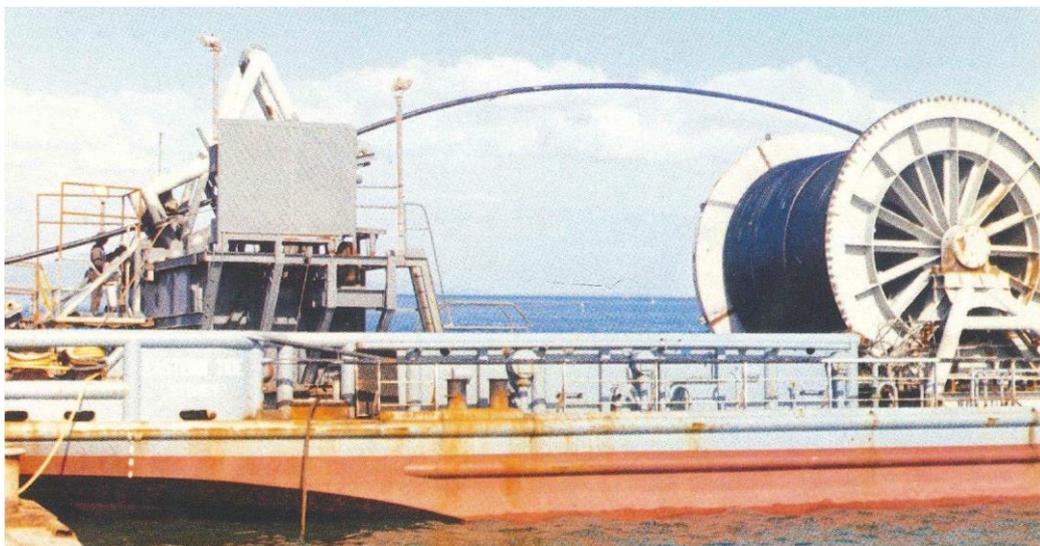
Figure 3: 114mm diameter steel pipe coated with FBPE being reeled onto a large barge – circa 1979

In the 1970's there were steel pipe manufacturing plants in every state, and because the only FBPE coating facilities were in Melbourne, supply of FBPE coated pipe was confined to Victoria until 1984. In the first 10 years of supply over 400km of steel pipe was coated with FBPE in sizes from 114mm to 1752mm in diameter. Of interest was the application of the coating system to 33km of 114mm diameter x 12.5mm wall thickness oil pipe (in 1978) that was welded into a continuous “string”, reeled onto a 4m diameter drum and unreel into Bass Strait. The pipeline conveyed hot oil at 100°C. A photograph of the reeling operation is shown in Figure 3.

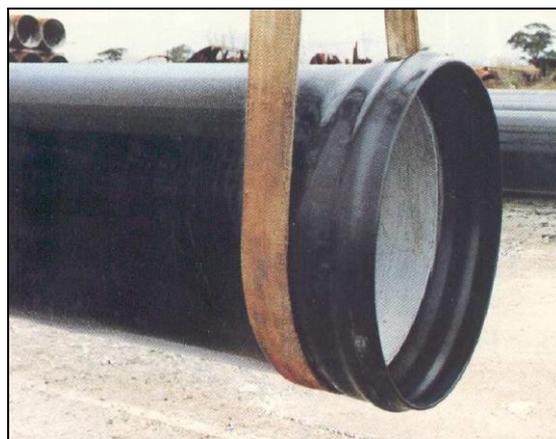
Figure 5: Photo of elastomeric socket coated with FBPE – as used in the water industry

system was first applied to the ends of elastomeric jointed pipes, together with the water industry's preferred cement mortar lining, this meant that no field joint coating was required – see Figures 4 and 5.

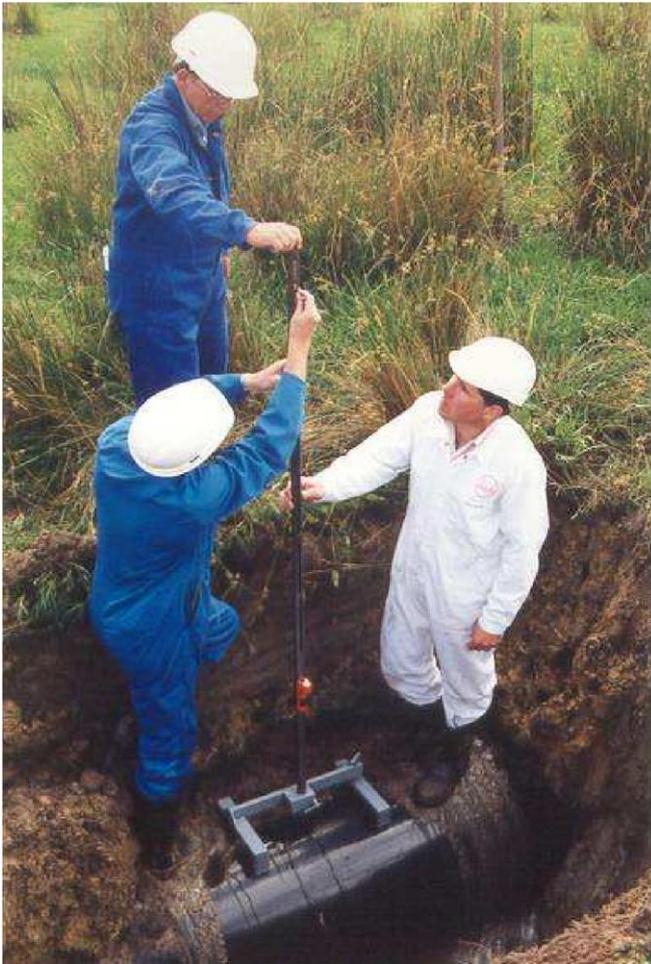
Figure 6: Site 1, Horsham, 1991, showing the 8 year service, 724mm pipe, and preparations for impact testing

Site 1 - A 724mm diameter buried steel water pipeline installed in 1983 was examined in November 1991 in conjunction with the owner/operator, GWMWater (formerly Horsham Water Board) and an industry expert who had worked at SR & WSC.

Impact testing was done in accordance with the German standard DIN 30670 as this was the most relevant standard that contained requirements for impact testing of low density FBPE coated pipe. The coating easily withstood the required impact when high voltage continuity tested at 15kV. At site 3 the pipe was on a slope so the impact (which had to be done vertically) was a slightly glancing blow. To account for this geometrical restraint, a higher impact energy of 18J (44% above the minimum requirement) was employed. The coating passed this test exhibiting compression of the coating, with no cracking evident, as would be expected from newly applied coating.

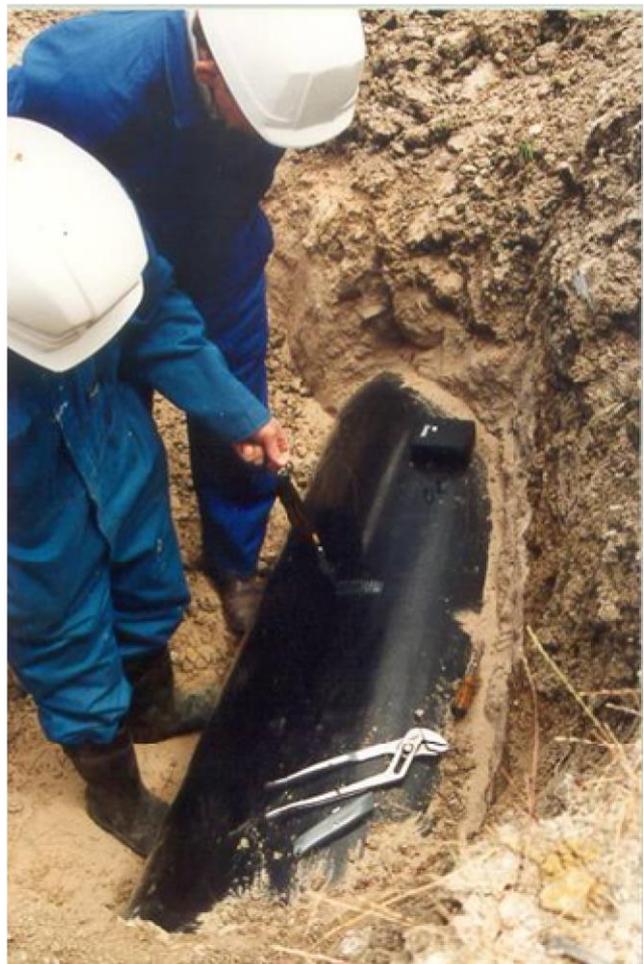
Figure 7: Site 2, Horsham, 1991, undertaking the bond adhesion test on the 724mm diameter, 14 year service pipe

Site 2 - A 724mm diameter buried steel water pipeline installed in 1977 was examined in November 1991 in conjunction with the owner/operator, GWMWater and the industry expert. The pipeline inspected at Site 1 was an extension of this pipeline.

Bond testing at all sites showed that the minimum requirement of 2.5N/mm was easily met except where the bond was so high that the coating broke before peeling occurred. The high bond strength meant that only two samples of sufficient coating size could be removed for the yield strength, elongation and ESCR tests.

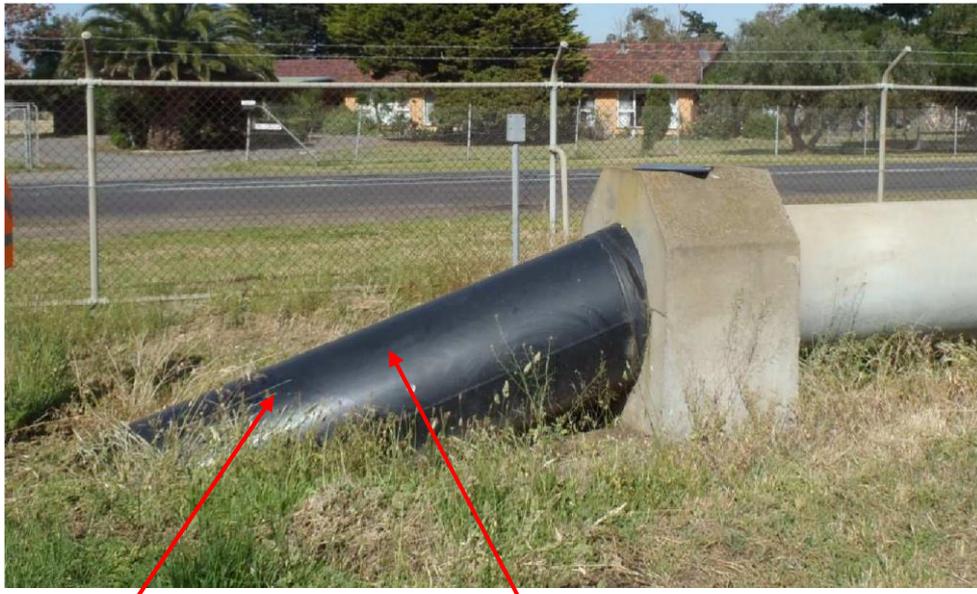
2004 inspection position

2013 inspection position

Figure 8: Site 3, Geelong, 2004 & 2013. Above ground pipeline section

Site 3a - A 813mm diameter above ground section of steel water pipeline in Geelong was examined. It was installed in 1978, and was examined in December 2004 in conjunction with the owner/operator, Barwon Water. A second examination was undertaken at this site, immediately adjacent to the original site, in December, 2013 with Barwon Water and a Research Engineer from CSIRO.

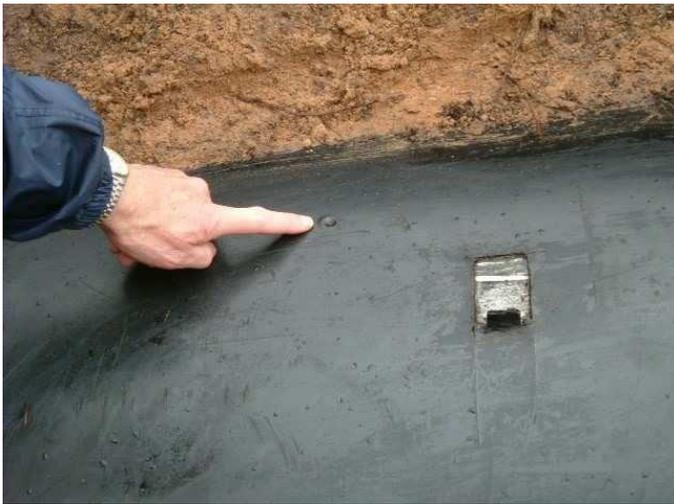
Figure 10: Site 3, Geelong, 2004. Buried pipe showing impact test indentation and bond test. Figure 11: Site 3, Geelong, 2013. Bond testing the buried pipe.

Site 3b - A 813mm diameter buried steel water pipeline in Geelong was examined. The pipeline is an extension of the above ground pipeline discussed above in Section 3a. It was examined in December 2004 in conjunction with the owner/operator Barwon Water. A second examination was undertaken at this site, immediately adjacent to the original site, in December, 2013 with Barwon Water and the CSIRO researcher.

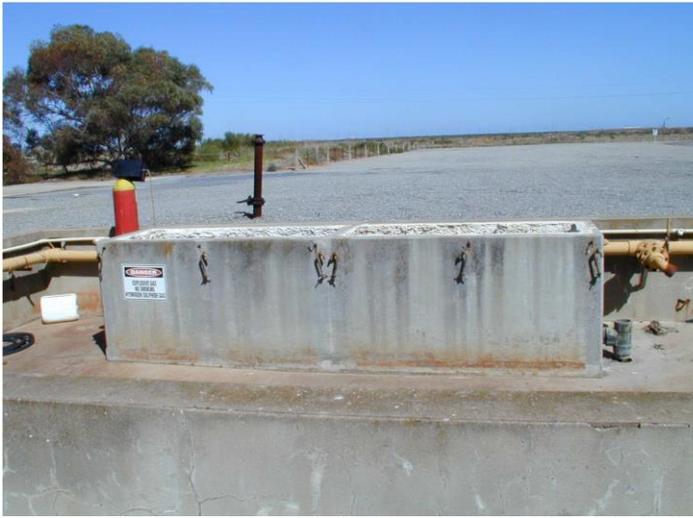
Figure 12: Sewage test chamber

Small test panels were supported vertically and half immersed in flowing raw sewage at the Bolivar Waste Water Treatment Plant which is located north of Adelaide (see Figures 12 and 13). The vapour space is supplemented with the addition of chemically pure hydrogen sulphide gas and maintained at approximately 40 to 50 ppm. Panels were removed, cleaned and assessed at 6 monthly intervals. One panel had been under test for 7 ½ years and the other for 8 ½ years. No rusting, blistering or other changes have been observed during this time exposed to raw sewage and sewage gas. It is of interest to note that most high performance protective coatings fail or show signs of failure in this test in less than 2 years.

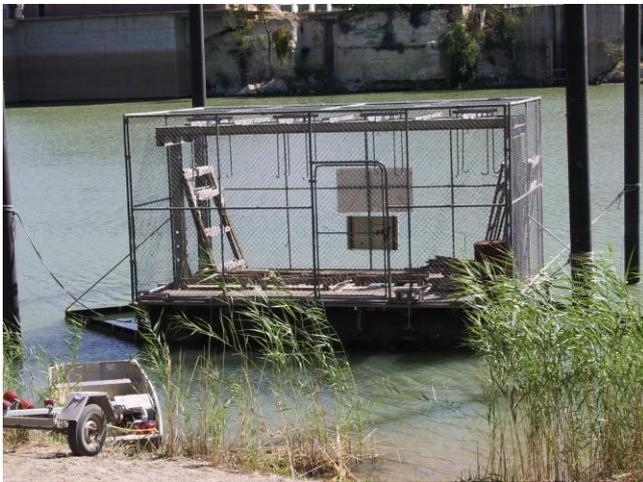
Figure 14: Murray River Pontoon for immersion exposure

Large panels were supported vertically in timber frames which were supported by a floating pontoon moored in the River Murray at Morgan in South Australia (see Figure 14). The upper panel was half immersed in water with its upper half exposed to shaded rural atmospheric exposure and a narrow zone of splashing. A fully immersed panel was fixed directly below the half immersed panel. The panels were assessed after 10 years exposure when no rusting, blistering or other changes were observed after these river exposures.

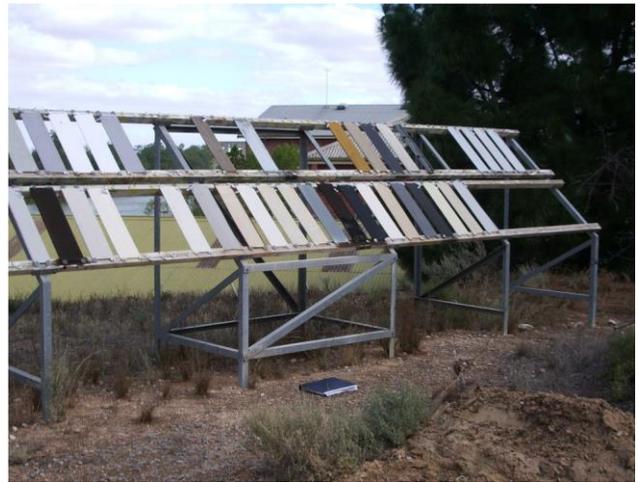
Figure 15: Atmospheric test racks at Morgan

Large panels were fixed to test racks which face a northerly direction at an inclination of 45°. The site is located on the cliffs above the River Murray at Morgan where high UV and summer temperatures in excess of 40°C are experienced. The FBPE coated panels were last assessed after 10 years exposure, when minor chalking (Rating 9 to AS/NZS 1580 Method 481.1.11) was observed. No other changes were evident.
