Steel Mains Pty Ltd
ABN: 73 004 843 056

Materials & Products – Coatings
Ref: PT 15271B
Date: January 22, 2019

Examination of SINTAKOTE® in Service

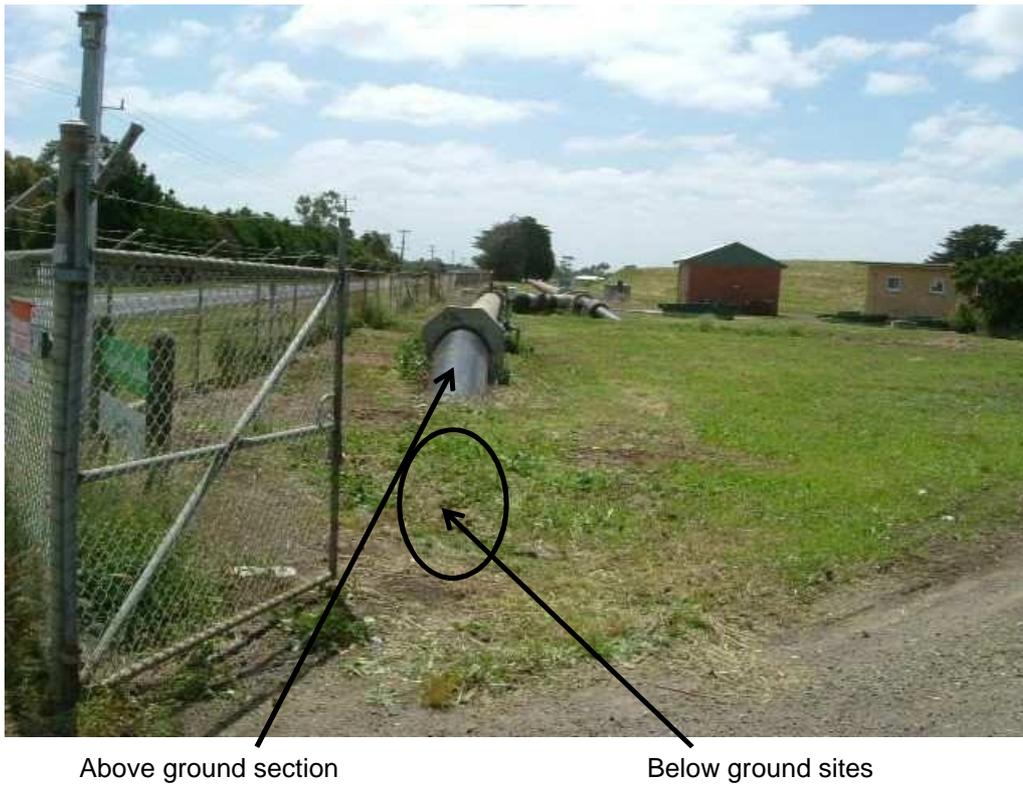
Figure 5 – Site 3, Geelong 2004 & 2013, showing a general view of the test sites at Lovely Banks reservoir site (facing NNW).

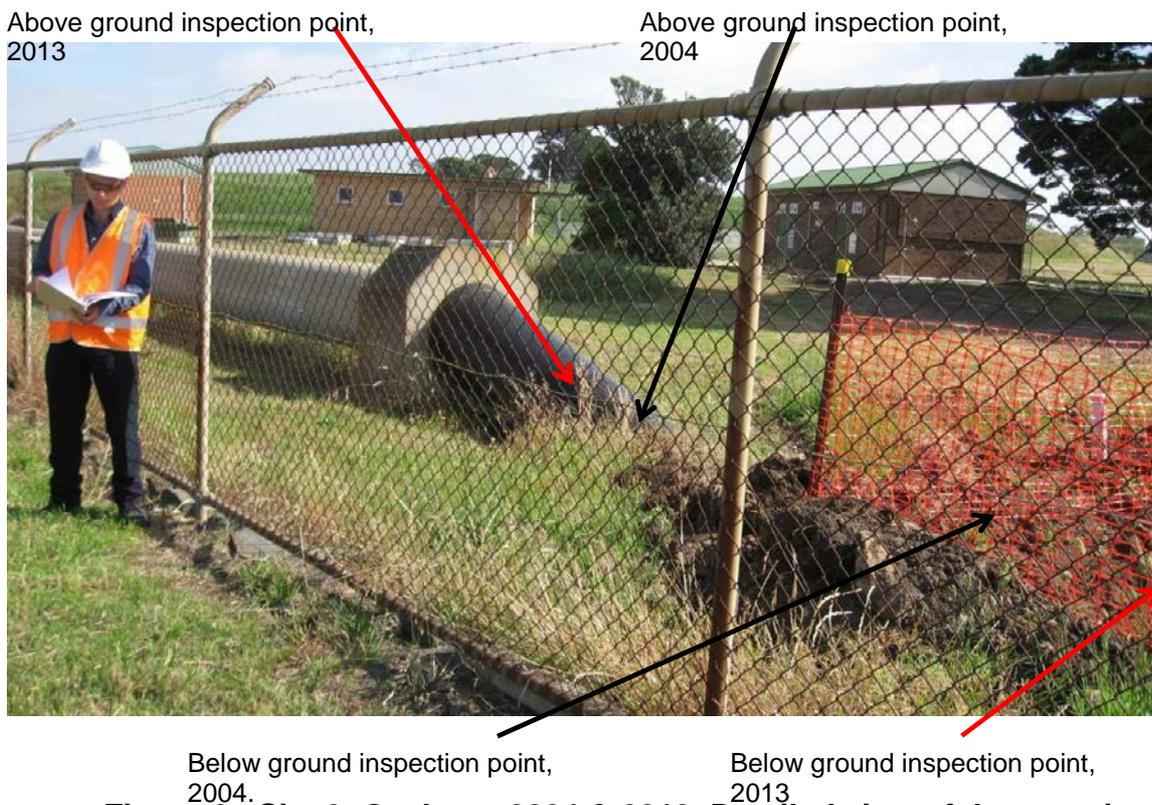
Figure 6 - Site 3, Geelong, 2004 & 2013. Detailed view of the test sites showing regions of examination (facing North).
