Pipeline Repair Products

Repair Patch and Butyl Mastic Filler

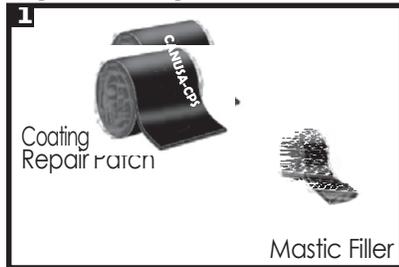
The Coating Repair Patch (CRP) is typically shipped in bulk rolls and can be cut-to-size in the field. Mastic Fillers are used to repair holidays and/or fill voids.

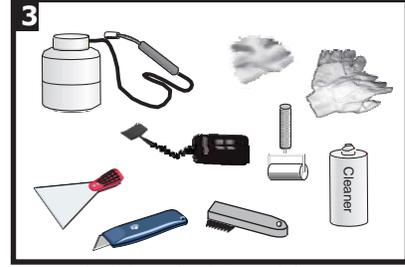
Equipment List

Propane tank, hose, torch & regulator. Appropriate tools for surface abrasion and cleaning, including wire brush, abrasive paper, rags & approved cleaner. Temperature measuring device. Misc. tools such as; knife, putty knife, roller, paint brush or paint roller, tape measure, and marker. Standard safety equipment; gloves, goggles, hard hat, etc.

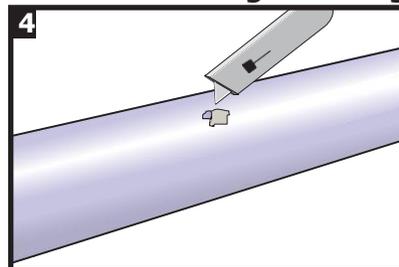
Removal of Damaged Coating

Remove damaged coating with a knife or hand grinder to prevent crack propagation in the coating.

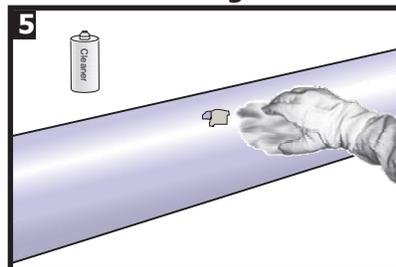
Solvent Cleaning

Clean exposed steel and adjacent pipe coating with an approved cleaner (as per SSPC-SP-1) to remove the presence of oil, grease and other contaminants.

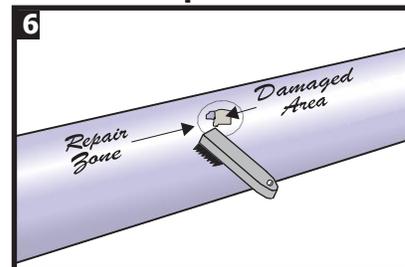
Surface Preparation

Remove adhering rust, coating chalk, dirt, and roughen the mill applied coating in the repair zone using an abrasive paper/cloth or wire brush.

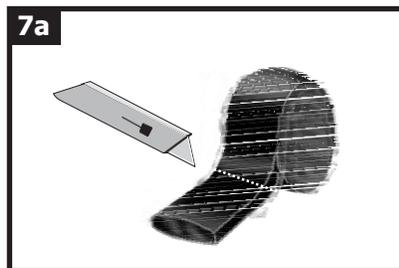
Mastic Filler Installation

Fill deeper crevices with UCC Butyl Mastic strip. Unroll the filler material and cut off the required amount, leaving the release paper in place.

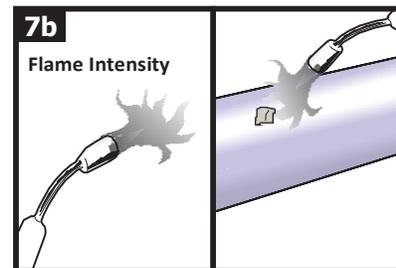
Use a low intensity yellow flame for pre-heating the coating and applying the repair products. With quick back and forth strokes, pre-heat repair area to 60°C minimum to remove moisture and assist in adhesion.

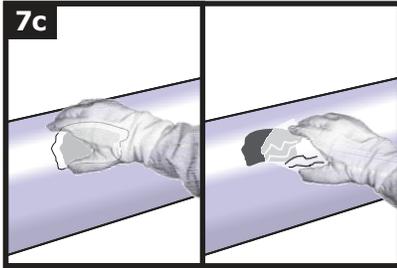
Place the filler material onto the damaged area with the release paper facing up. Firmly press the material into the damaged area by hand and remove the release paper.

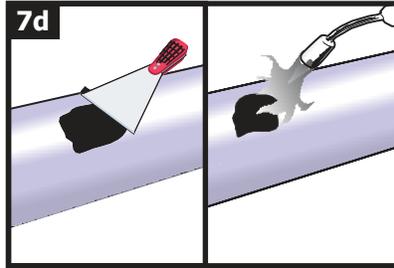
After filling the damaged area, remove the excess filler to create a smooth surface. As an option, use a low intensity yellow flame to warm the filler material and assist in smoothing it out.

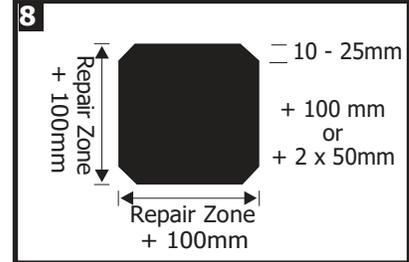
Patch Preparation

Cut a patch of CRP large enough to extend a minimum of 50mm (2") beyond the edge of the repair zone. Trim each corner of the patch about 10-25mm (½" - 1") at a 45° angle. If the damage has a diameter greater than 10cm (4"), use an appropriate heat-shrinkable sleeve.

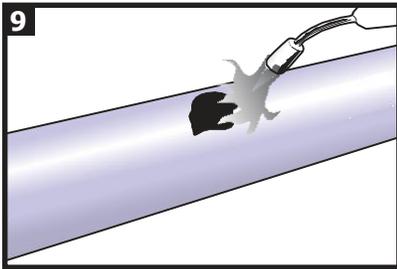
Pre-Heat

Warm the damaged area (repair zone + 50mm (2") overlap) to remove moisture and assist in adhesion.

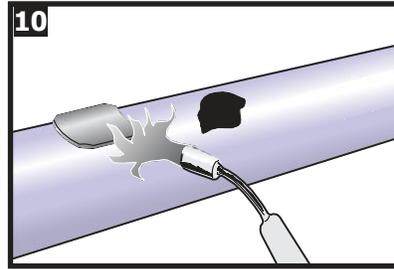
Patch Installation

After removing the release liner from the cut patch, place the patch with the adhesive side up on a gloved hand, on top of the pipe, and heat gently. Heat until the adhesive softens and the surface becomes glossy. Also, reheat the damaged area to keep it warm.

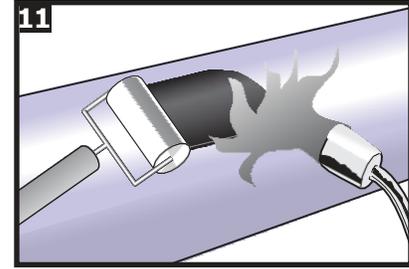
Apply the softened adhesive side of the patch to the damaged area and press down firmly. Heat the patch with a low intensity flame, and using a roller or a gloved hand, pat down and remove wrinkles. Roll to ensure a good bond.

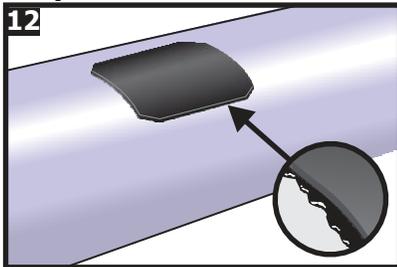
Inspection

Visually inspect the installed patch for the following:

1. Patch is in full contact with the pipe coating.
2. There are no loose edges.
3. A successful patch has adhesive flow on the edges.
4. The patch has fully conformed to the coating.
5. No cracks or holes in patch backing.

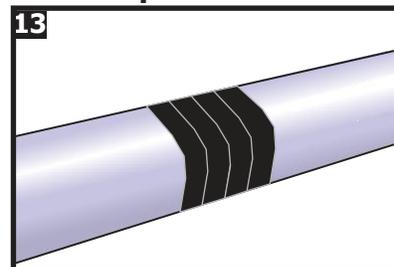
Overwrap Patch

Spirally overwrap the patch with UCC PVC overwrap extending about 150mm either side of the patch.
